# **Air Braked Commercial Motor Vehicles Problems Solved, Problems Created**

**David A. Stopper, Adjunct Staff  
Commercial Vehicle Collision Reconstruction  
Texas Engineering Extension Service  
Law Enforcement & Security Training  
Division  
Texas A & M University**

***Presented at the South Carolina Accident Reconstruction Conference March 2001***

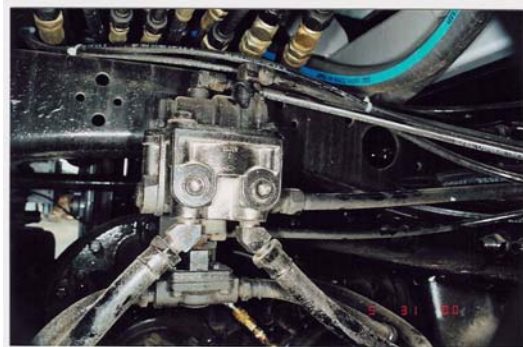
*BP-R1 valve with its distinctive three-tier valve incorporated into the top of a relay valve.*

bobtail truck tractors (truck tractors without semi trailers attached). They offered new valves referred to as the “Bobtail Proportioning Valve”. They have been marketed as the BP-1 & BP-R1 valves.

These two models of the valve were designed and have been very effective in reducing lateral control problems associated with over braking on the rear of the truck tractors. They are activated when the trailer supply line (the red hose to the semi trailer) and the trailer supply valve on the dashboard are closed. The valve reduces the rear brake pressure as much as 75% while allowing full brake pressure to the steering axle. If a full brake application is made, the rear brake pressures will quickly rise once 60-65 PSI application pressure is achieved.

Attachment of a Gooch™ Air Brake Analyzer quickly identified the problem. The truck still thought it was a truck tractor. With no semi trailer attached the trailer supply line was closed and the BP-R1 was doing exactly what it was designed to do. It was reducing the rear brake pressure until the brakes were applied above 60-65 PSI and the rear brakes would then kick in.

The solution was quite simple. Either replace the BP-R1 with a standard relay valve or plumb the control line, (a

narrow line that connects the top of the valve to the trailer supply / tractor protection valve) into a supply reservoir. The plumbing of the control line into the reservoir gives the BP-R1 the same signal as when a semi trailer is attached and the relay valve reverts to its normal full brake pressure relative to the steer axle.

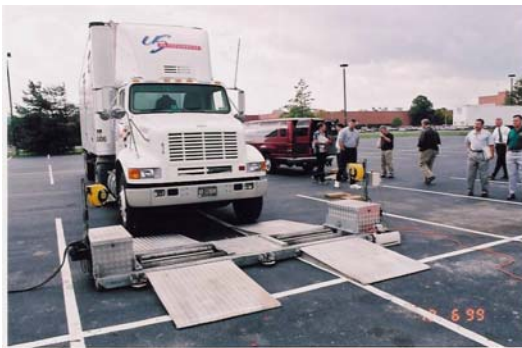
*Portable roller PBBT*

His product, the BM20200 roller PBBT is an electric treadmill design, which rotates the vehicle's wheels and measures the brake force as the brakes are applied. The roller PBBT is one of the only practical ways to dynamically test ABS, and traction control systems.

This PBBT can be equipped to weigh the vehicle and monitor brake pedal pressure while the test is being run. It is also available with an optional weight simulator. The weight simulator is a hydraulic system that attaches to the axle pulling it down against the treadmill. It can simulate weights up to 40,000 pounds.

This unit is available as an in-ground or a portable unit that weighs 2600 pounds. It can be transported on a car trailer and operated at random roadside or collision sites with a 3-phase/240-volt/14KW gasoline powered generator.
