THE EFFECTS OF AIR PRESSURE ON PUSH ROD STROKE MEASUREMENTS

Presented at
Pittsburgh, Pennsylvania, October 10-12, 1995
Updated for
S.C.A.R.S. Conference
North Charleston, SC July 24, 2007

By David A. Stopper, Director
Stopper & Associates
Motor Carrier Safety/Highway Accident Research

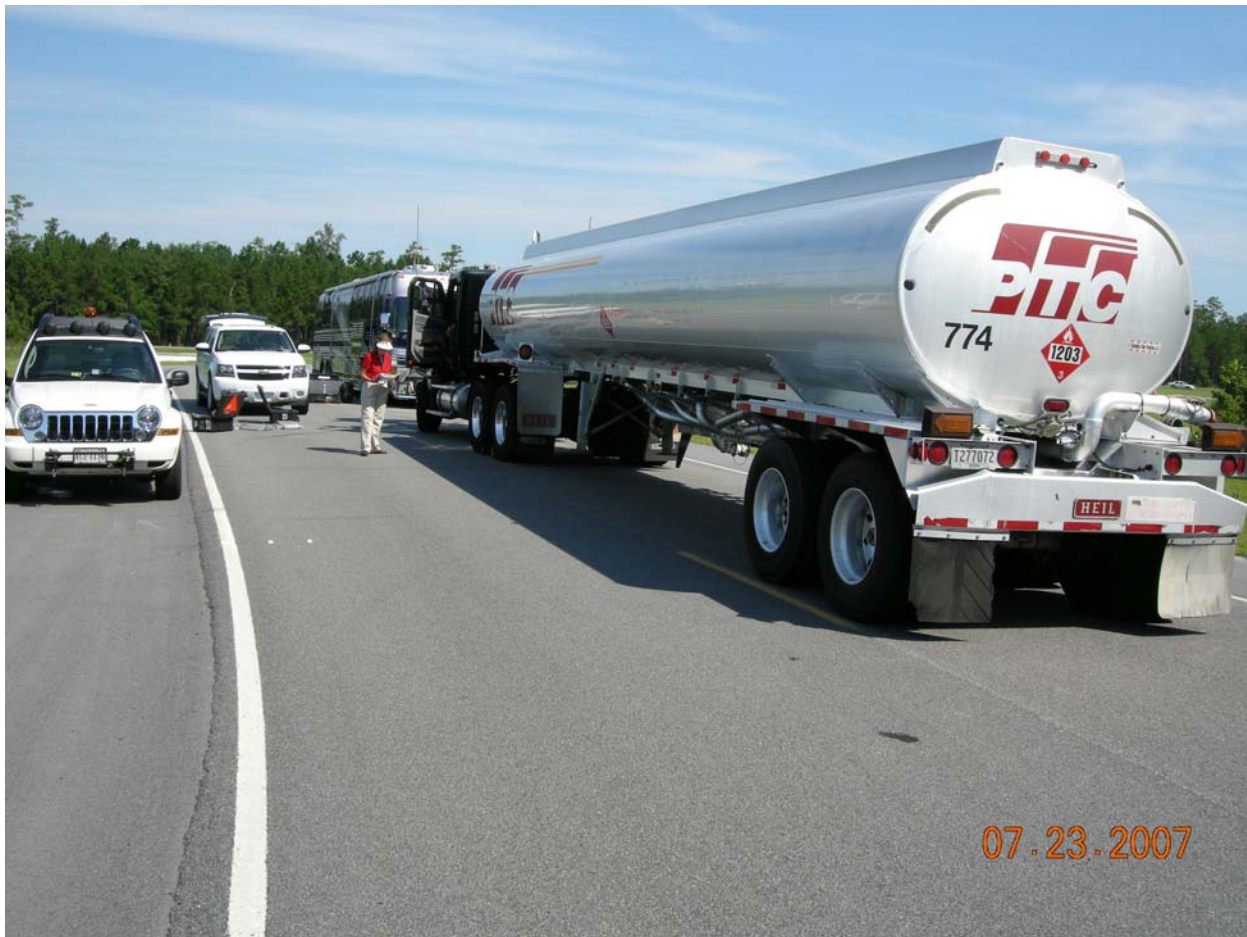
DATA FROM
SCARS CONFERENCE JULY 23, 2007
CHARLESTON, SC

03/07 Freightliner Columbia w/ABS brakes
08/97 HEIL Fuel Tanker Semi Trailer
Test Date 07/23/07

CHAMBER TYPE	AXLE	L 30 PSI	L 60PSI	L 90PSI	R 30PSI	R 60PSI	R 90PSI
T-20 5.5" ABA	1	7/8"	1 1/8"	1 1/4"	7/8"	1 1/8"	1 1/4"
30/30 5.5" ABA	2	1 1/8"	1 1/2"	1 9/16"	1"	1 3/8"	1 1/2"
30 5.5" ABA	3	1 1/8"	1 3/8"	1 1/2"	1 1/8"	1 1/4"	1 3/8"
30/30 5.5" ABA	4	1 1/4"	1 3/8"	1 7/8"	1"	1 1/4"	1 5/8"
30/30 5.5" ABA	5	1 5/8"	1 3/4"	2 1/8"	1 1/8"	1 1/4"	1 1/2"
